Analysis of Major Causes of Accidents in Egyptian National Railways and Cairo Metro Lines

¹Dr. Ahmed Abd El-moamen Khalil

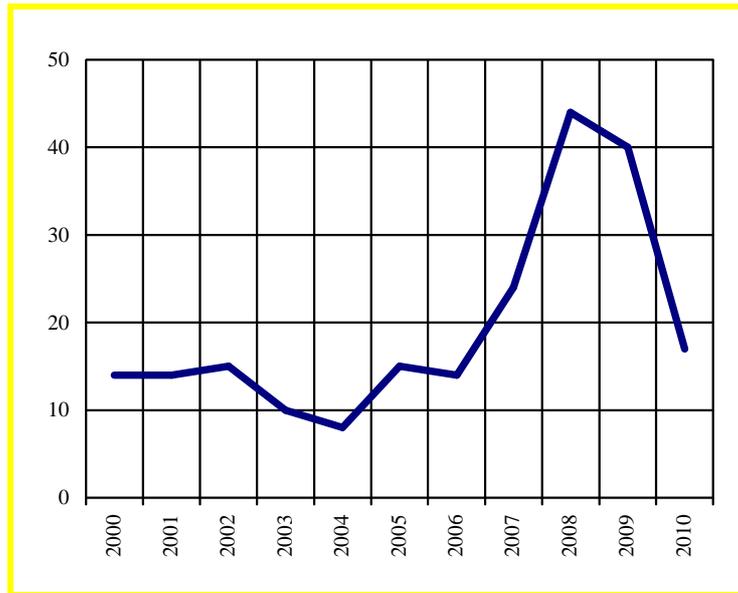
Figure 1: Frequency of SPADs during the period from 2000 to 2010

In Table 2, statistics for SPAD accidents that have occurred in the period from 2000 to 2010 are shown [7]. It is clear from chart in figure 1 that No. of accidents has increased gradually from the minimum value (8) in year 2004 to reach peak value (44) in year 2008 and continued high during year 2009. The SPADs were coming down in year 2010 to more than half of the records of the former three years as the drivers were subjugated to many restricted control rules despite increasing No. of ATC breakdowns [7]. The second reason for decreasing the No. of accidents was cancellation for one hundred trips on the rail network. It is also noticed that period from 2007 to 2009 is considered the worst for accidents due to SPADs.

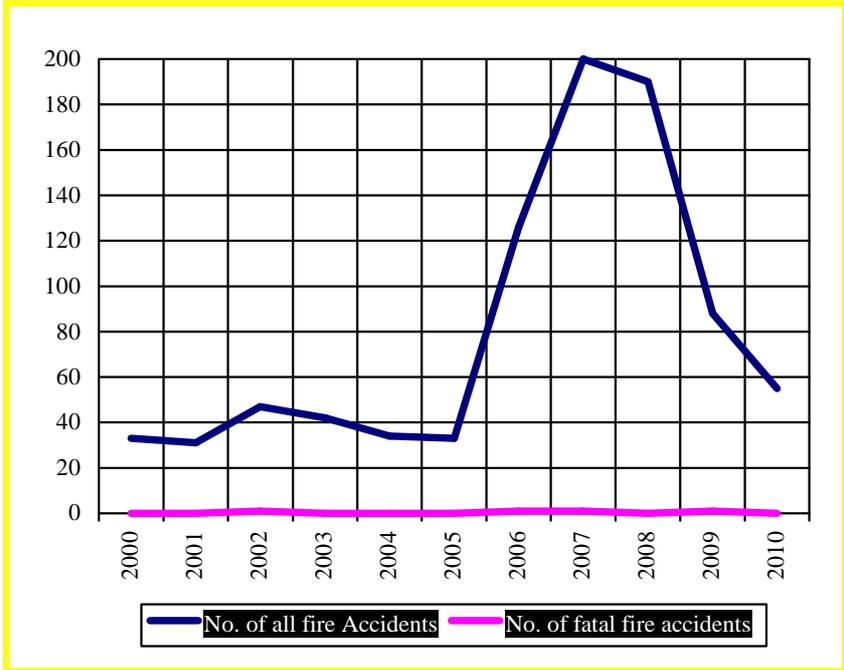
Figure 2: Chart for fire accident frequency from 2000 to 2010

Analyzing of accidents that represented in Figure 2, it is noticed that frequencies of accidents have increased gradually in year 2005 to reach the peak value in year 2007 and continued high in year 2008. The frequency has gradually decreased from year 2008 to reach minimum value in year 2010. The period from 2006 to 2009 is considered the worst for accidents due to fire.
